PORTUS

LA CINTA MURARIA (V-IX secolo)

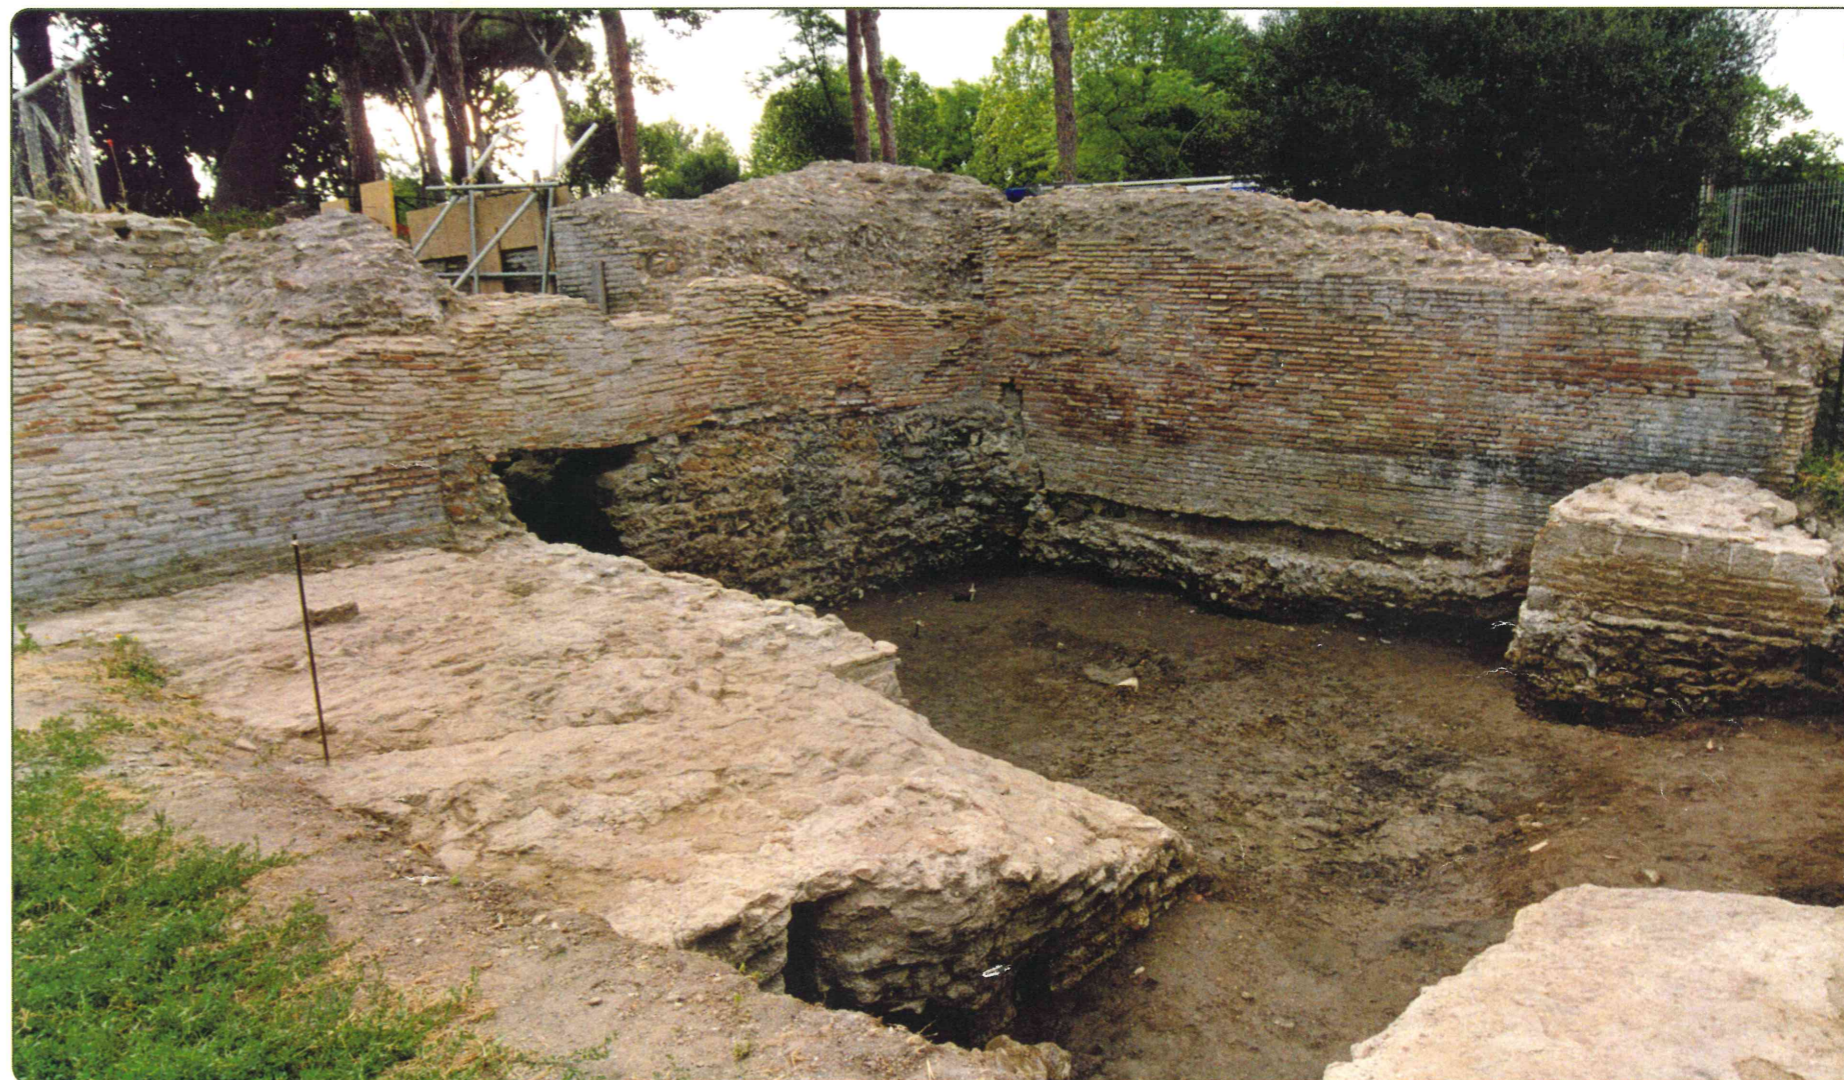
Veduta generale dell'area di scavo

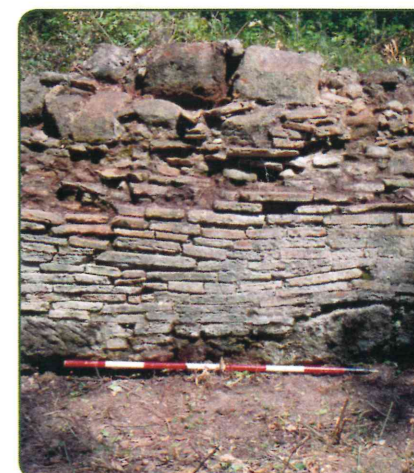
Particolare del restauro altomedievale

La cinta muraria rimase in funzione per tutto l'altomedioevo subendo diversi restauri. In questo settore il primo intervento è relativo alla costruzione di un contrafforte risalente al VII secolo a cui seguirono altri restauri volti a risarcire il fronte delle mura, esposto ai venti marini, mediante una nuova cortina. L'ultimo restauro, caratterizzato dalla tipica opera laterizia a ricorsi ondulati, è ascrivibile all'iniziativa di Papa Leone IV intorno alla metà del IX secolo.
